Re: The Doe Run Company - Leadwood Mine Tailings Site Monthly Progress Report

Leadwood Mine Tailings Site
Leadwood, Missouri
Removal Action - Monthly Progress Report
Period: August 1, 2013 – August 31, 2013

This report details the findings of the inspection, and gives preliminary overviews of potential design options for the decant tower structure, as well as potential future investigative measures.

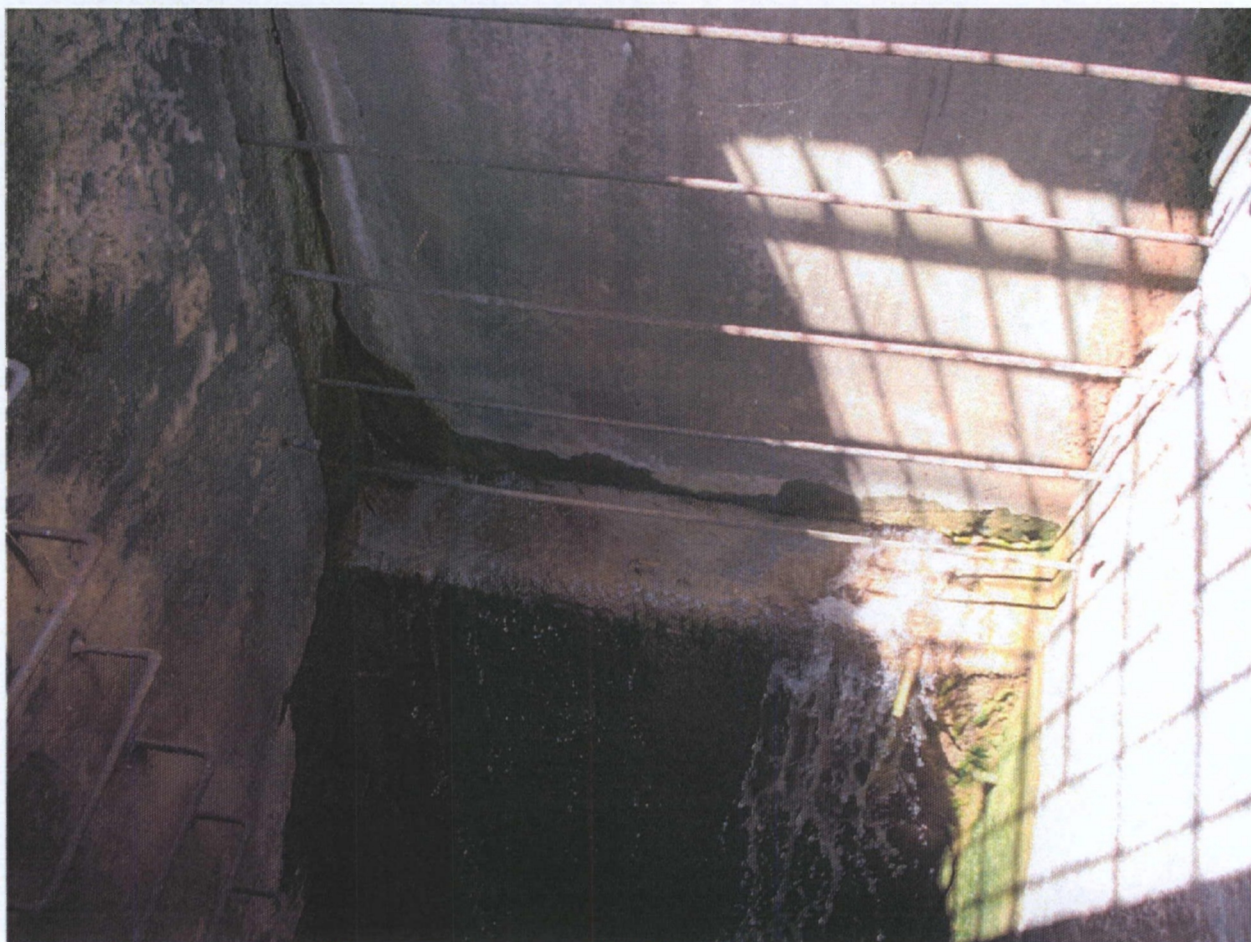
- Approximately 10 feet below the top of concrete on the west wall, there is a concrete bulkhead blocking a 5.5 feet by 7 feet opening in the main shaft wall. A large volume of water has continuously been observed flowing through the bottom seam between the bulkhead and wall opening. The flow rate out of the seam varies based on surface conditions but is estimated to have be as high as 1,000 gallons a minute. During low flow conditions, grey sediment has been observed on the bottom ledge of the opening (See Photographs 1 and 2 in Appendix B).

Photograph 1-Seam at concrete bulkhead, south shaft, looking west; this location was observed to be the primary source of seepage into the decant structure

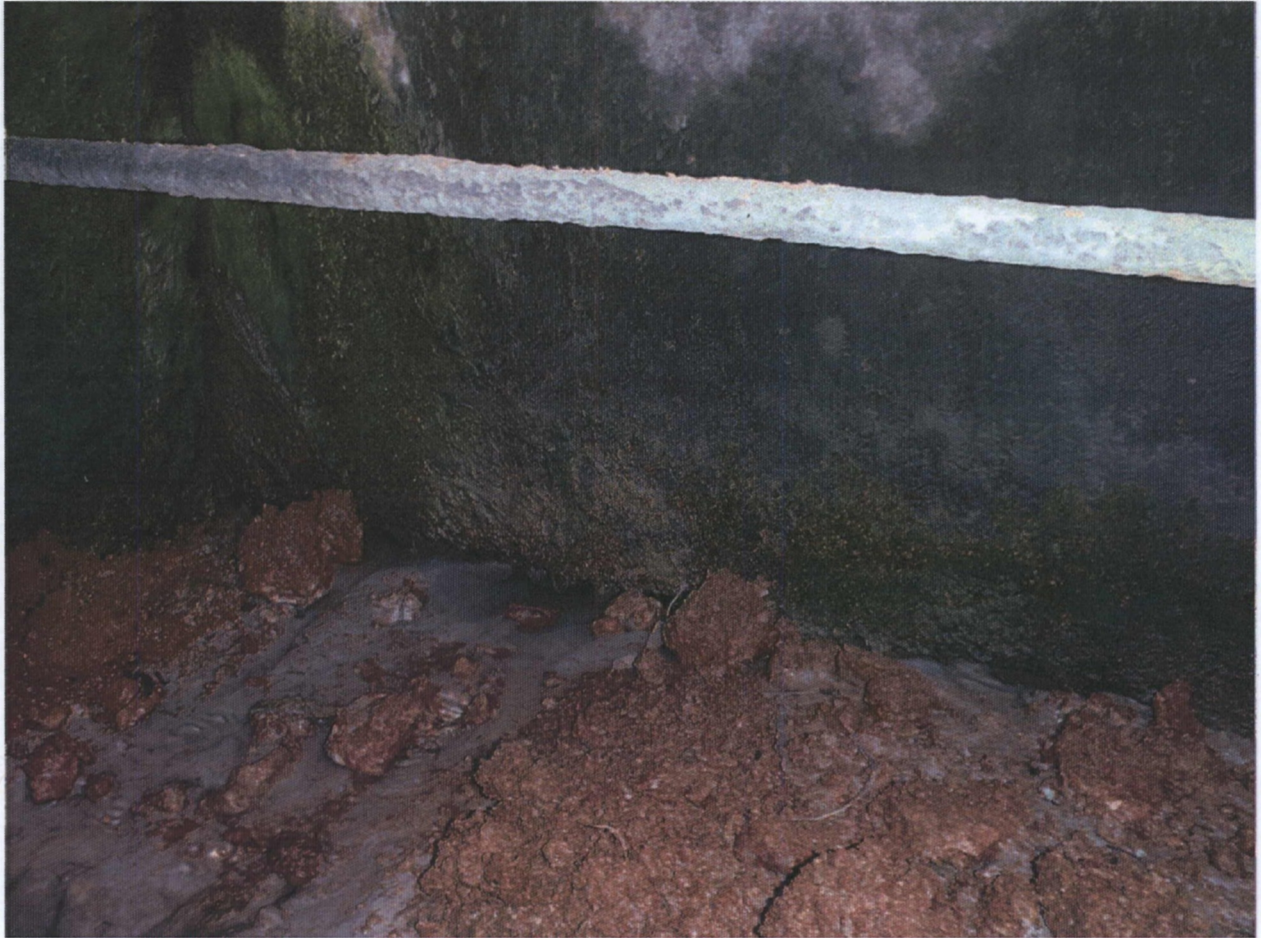
Photograph 2-Seam at concrete bulkhead, south shaft, looking southwest; red sediment is clay that was used for water control, and was deposited during inspection preparation; gray sediment is assumed to be scouring into the decant structure

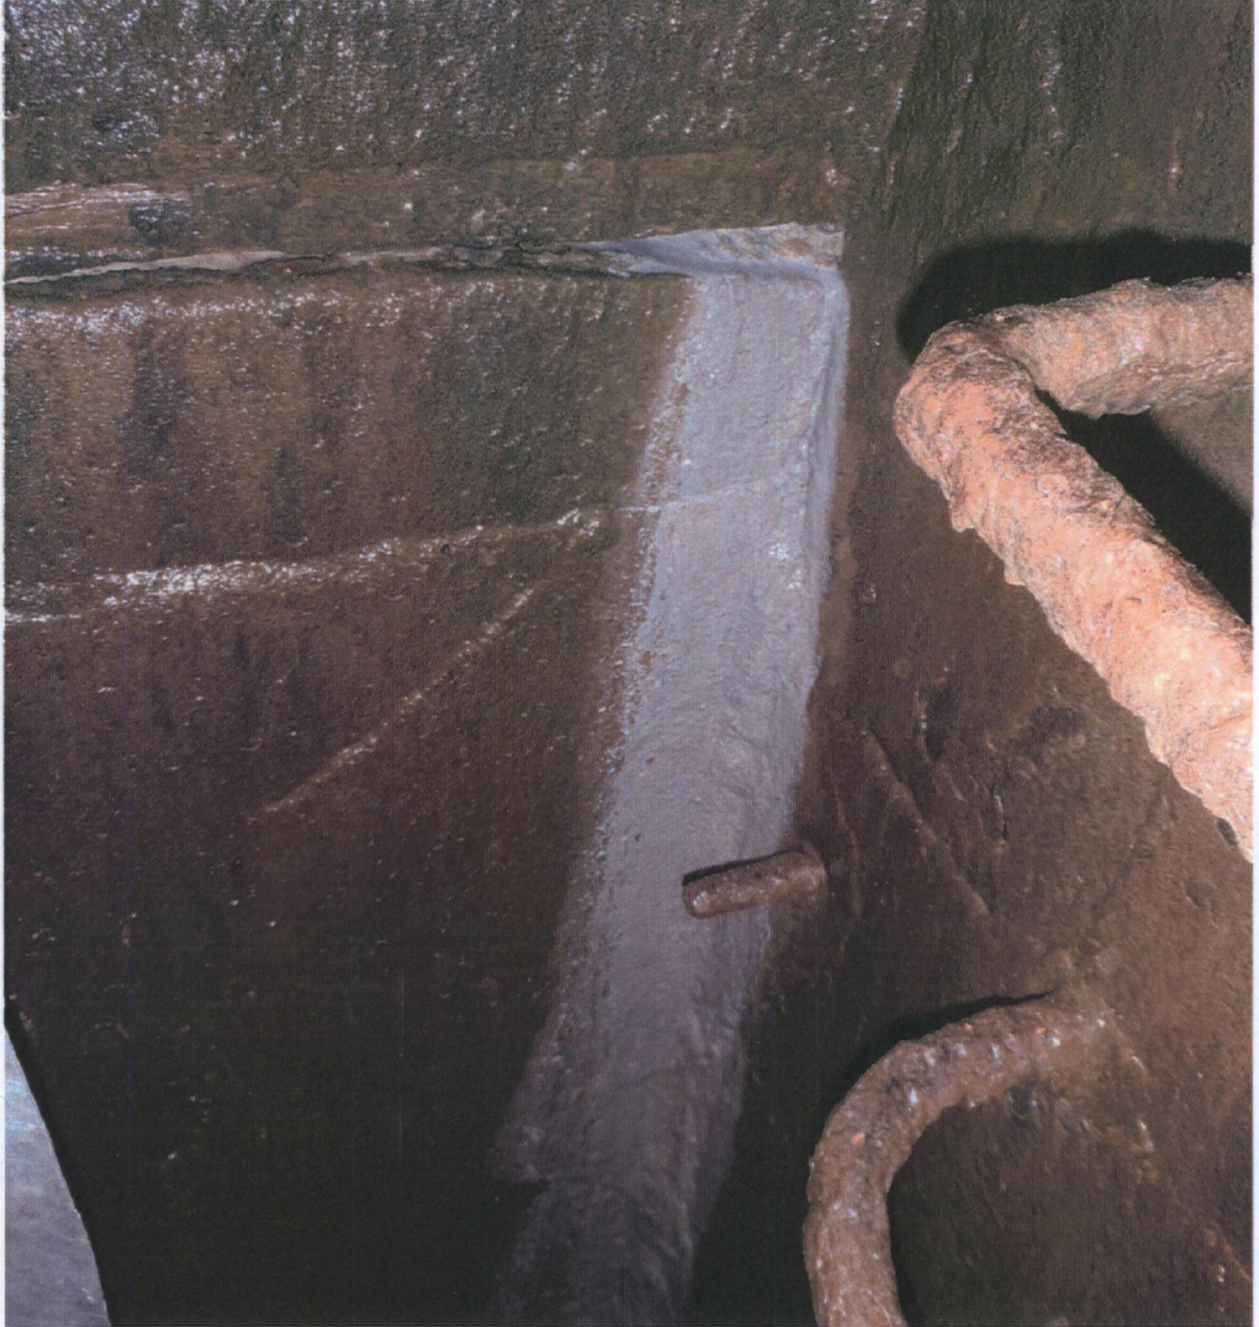
- Approximately 28 feet below the top of the concrete, a form board is present at a seam on the east wall. Beneath the form board in the south-east corner of the shaft, water infiltration was occurring at an estimated rate of 2 gallons per minute. A fine, light grey sediment was suspended in the water, and had created a light gray trail of residue down the side of the tower shaft (See Photograph 3 in Appendix B).

Photograph 3-Fine white sediment infiltrating tower, south shaft, looking southeast

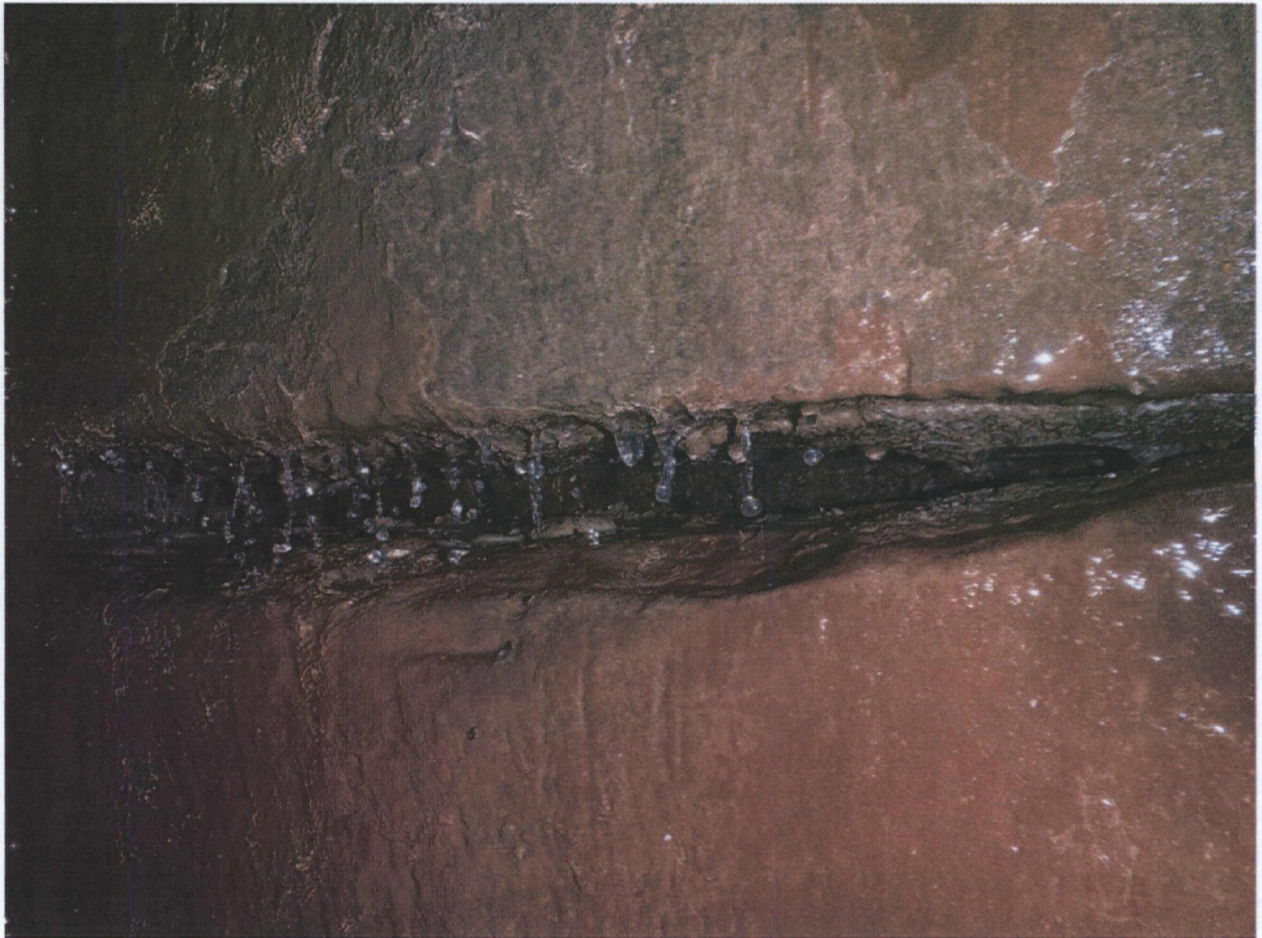
- Approximately 33 feet below the top of the concrete, in the south-west corner of the shaft, a large gap was present. The gap was tapered with a maximum width of 5 inches, and extended about 20 inches into the wall. A flat solid surface was encountered at the back of this cavity, and is assumed to be a concrete bulkhead. The gap was very wet, however it is unclear whether seepage from the surrounding tailings was infiltrating at this location or if the water was a result of condensation or water flowing from cracks higher in the wall (See Photograph 4 in Appendix B).

Photograph 4-Large gap at seam, south shaft, looking southwest

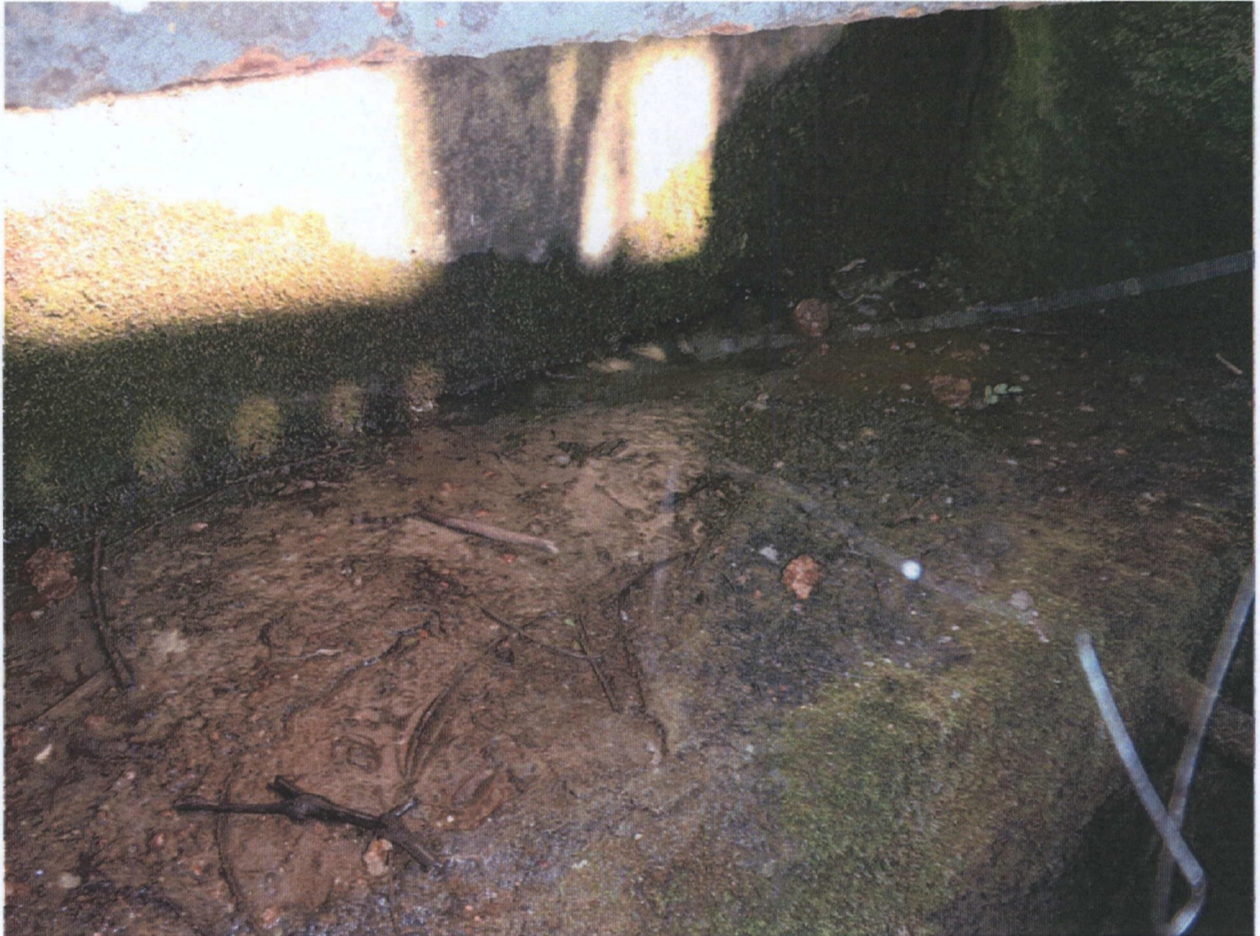
- Approximately 9 feet below the top of the concrete in the north-east corner of the shaft, several small cracks were releasing orange colored sediment. The sediment had accumulated in a trail down the side of the shaft wall and was fine to medium grained. The cracks were wet (See Photograph 5 in Appendix B).

Photograph 5-Cracks with sediment infiltrating tower, north shaft, looking northeast

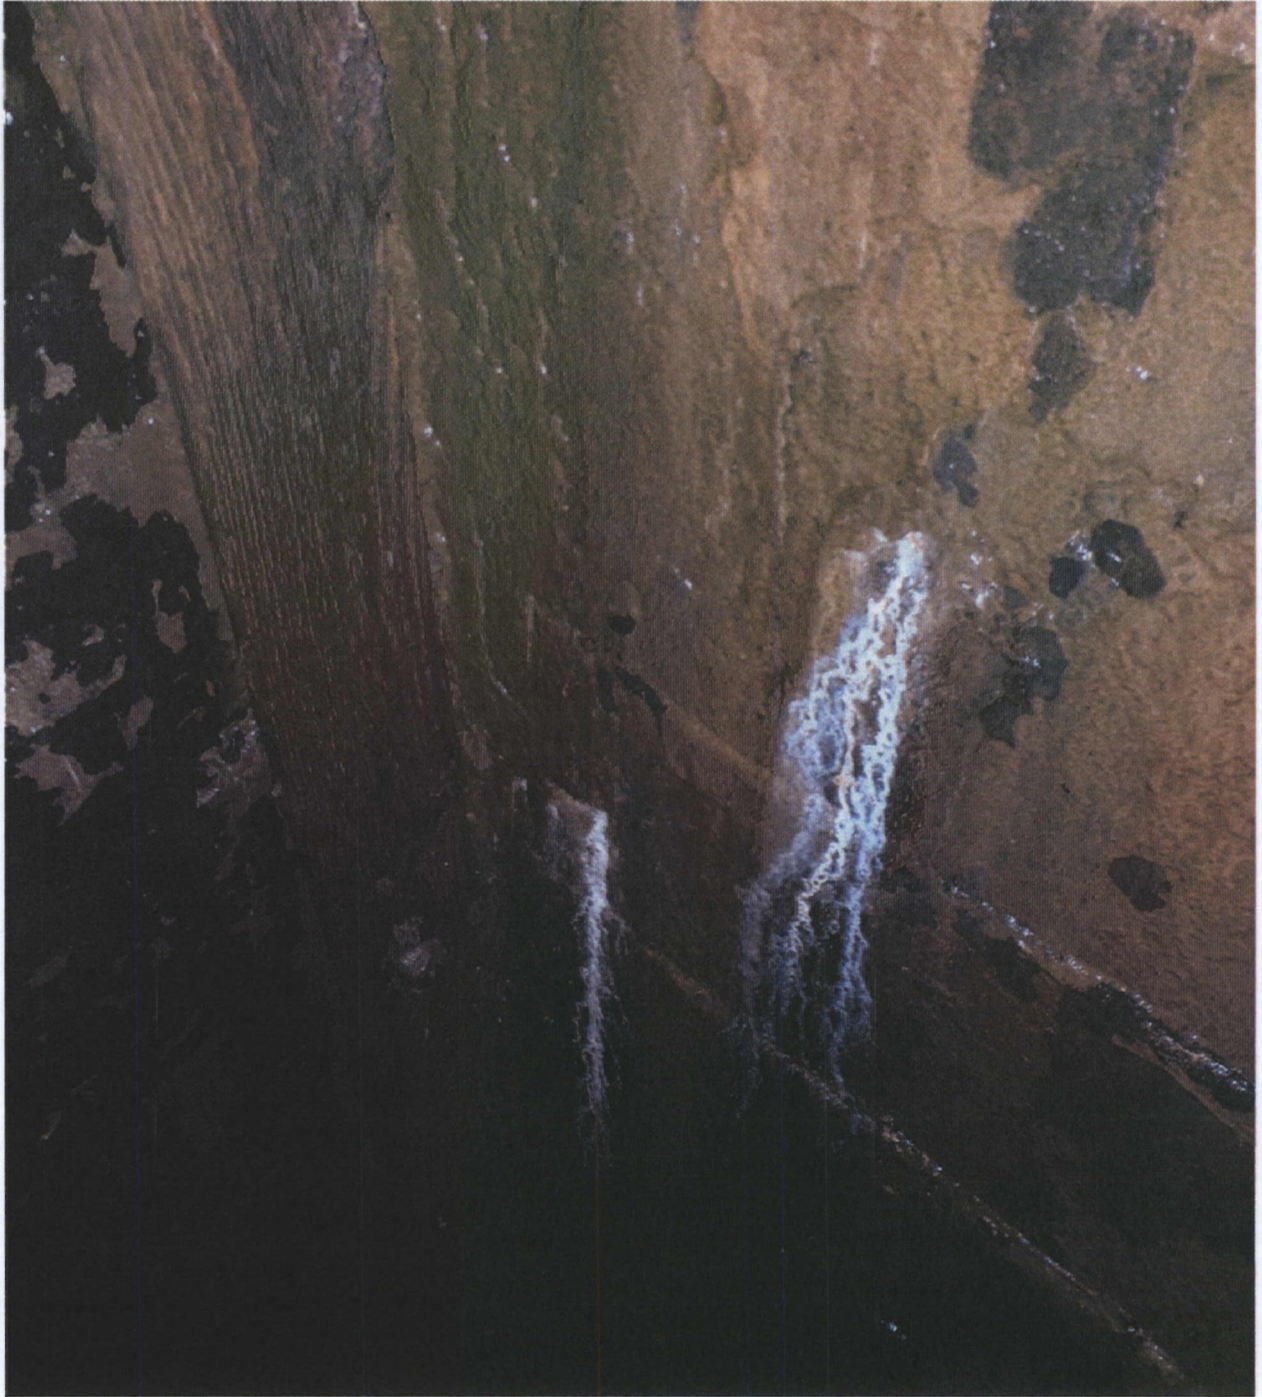
- Approximately 17 feet below the top of the concrete a crack in the north-west corner of the shaft showed signs of the same white residue noted in the south shaft. No visible discharge appeared to be coming from the opening during the inspection (See Photograph 7 in Appendix B).

Photograph 7-White sediment infiltrating tower, north shaft, looking northwest

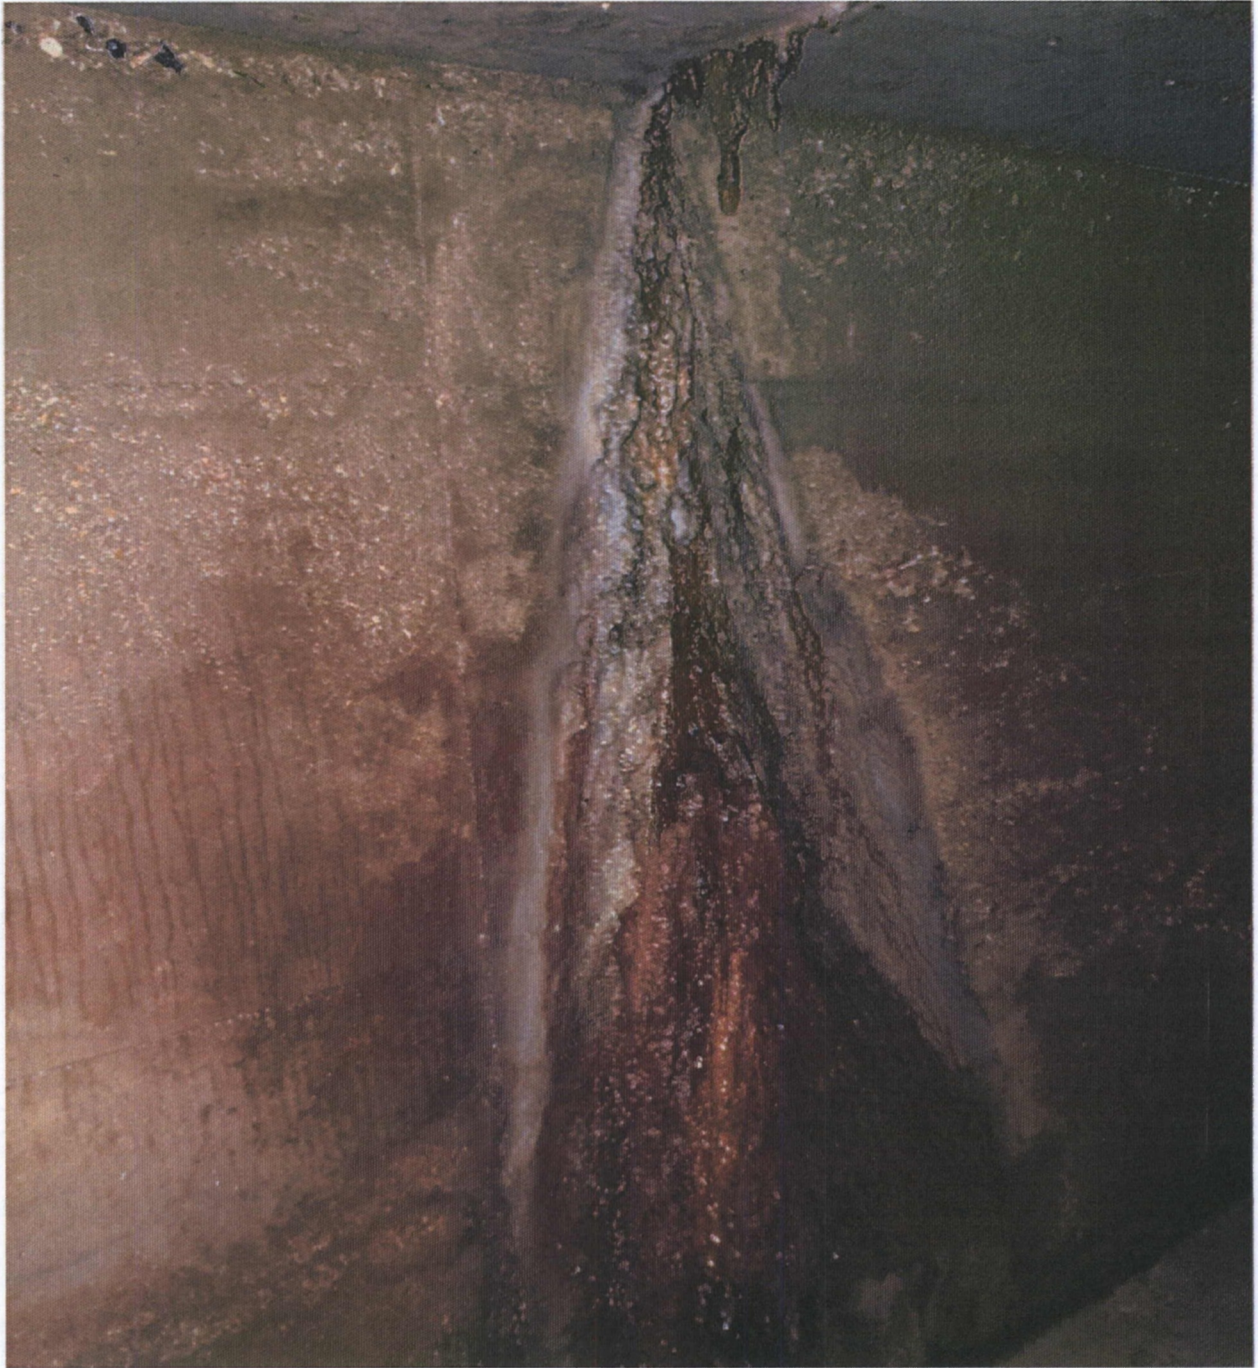
The presence of iron bacteria and darker discoloration was observed approximately 100 lineal feet from the culvert discharge. It continued to be present at seams and cracks through the rest of the length of the culvert leading to the decant tower. The mineralization varied from surface discoloration to formations that protruded as much as 6 inches from the concrete surface and formed stalactites from seams and fissures in the culvert ceiling (See Photograph 9 in Appendix B).

Photograph 9-Mineralization (iron oxidation and efflorescence) in culvert, approximately 450 lineal feet from culvert discharge, looking southeast
